SOUTHWEST UNITED INDUSTRIES, INC.

Product Repair Data Sheet

737 Hanger Link Assembly

PART No: 161A4300-1, -2

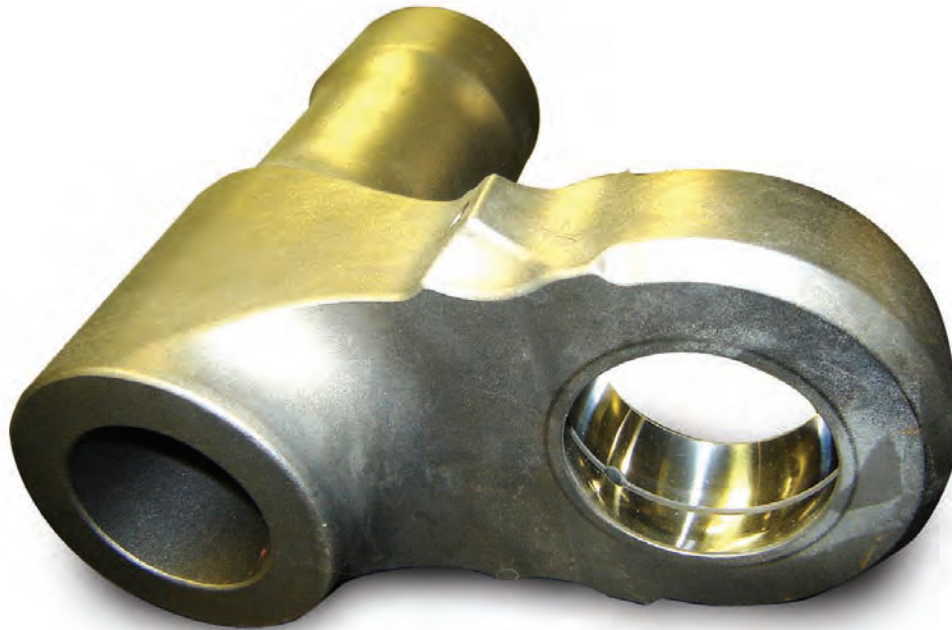
Southwest United's HVOF coating outperformed all others during testing at Boeing's BMT facility. HVOF coating is the only coating approved in Boeing's CMM.

- DISASSEMBLE BUSHINGS AND LUBE INSERTS
- STRIP HVOF COATING ON SPHERICAL ID
- BLEND OR PRE-MACHINE AS REQUIRED
- SHOT PEEN
- APPLY HVOF TO SPHERICAL ID
- GRIND SPHERICAL ID AND PENETRANT INSPECT
- INSTALL BUSHINGS AND LUBE FITTINGS
- TAG AS OVERHAULED (CMM 32-11-13)
